2005 BANK EROSION MONITORING REPORT

SAN ACACIA REACH OF THE RIO GRANDE, NM

Final Report

**Department of the Interior
Bureau of Reclamation
Albuquerque Area Office**

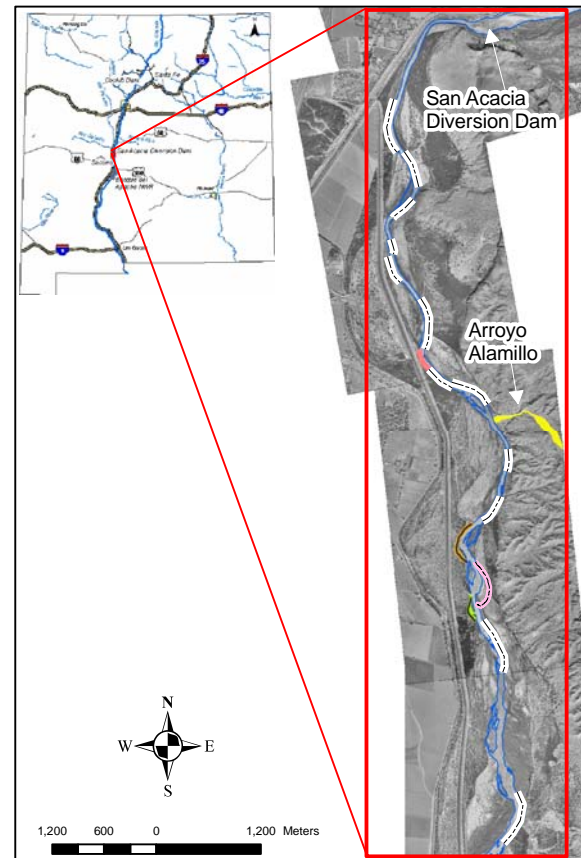
Figure 1: Location of the San Acacia Reach along the Rio Grande in New Mexico. The colored lines indicate banklines that have been mapped in detail. The white and black lines are banklines that were observed eroding during the 2005 runoff period.

Large sections of bankline are eroding upstream of Arroyo Alamillo (Figure 1), however all of this erosion appears to be simply ‘widening’ of the river channel. The eroding banklines tend to have a relatively long length, while the bend has a low curvature. The most important characteristic of these types of bends is the lack of active point bar growth opposite the bank erosion (Figure 18). Without ongoing deposition on the inside of the bend, the full cross section of the channel stays relatively deep and active at even low flows. Also these banklines did not retreat significantly during the runoff event.

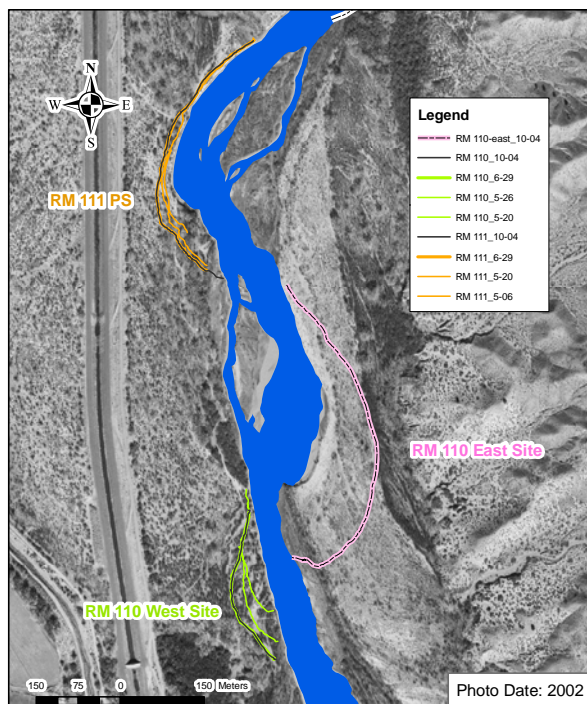
Banklines at three locations migrated significantly in the San Acacia area (Figure 5): RM 111 River Maintenance Priority Site (RM 111 PS), RM 110 West Site and RM 110 East Site. The RM 111 PS and the RM 110 West Sites were visited regularly throughout the runoff event, and their banklines were mapped in detail several times, including after the runoff event was finished. As accessing the RM 110 East Site was not possible during the runoff event, this site was mapped in detail after runoff and only once (October 2005).

Figure 5: GPS mapped Rio Grande bankline locations at three migrating bends in the San Acacia Reach during Spring Runoff 2005; background is a geo-rectified 2002 aerial photograph.

Movement of the bankline at the San Acacia RM 111 River Maintenance Priority Site was ongoing throughout the 2005 spring runoff (Figure 7). A bankline survey on October 4, 2005 showed that no significant bankline erosion occurred after the June 30th survey (Figure 5). This bend generally migrated 60 meters at the bend apex in the downstream direction, while the downstream extent migrated about 110 meters downstream. The area of the bend increased by 25% in 2005 (Table 1). The bank material present at this site is a combination of spoils and historical Rio Grande floodplain and riverine sediments composed of sand and silt. The bank is 8-10 feet (Figure 6) and varies between a vertical exposure and a slight lay-back.

The three bends between RM 111 and RM 110 which were described earlier, are classic examples of migrating bends. Although these bends became quite large during 2005, they have a curvature that is relatively tight compared to the ‘widening’ bends found upstream of Arroyo Alamillo. Most distinctively, large point bars (Figure 19) were observed growing as the bankline retreated, in fact, these point bars emerged just after the runoff peak and remained emerged as water level decreased. The retreat of the bankline was not only significant, but large enough to warrant periodic mapping to determine rates of movement (Figure 5).

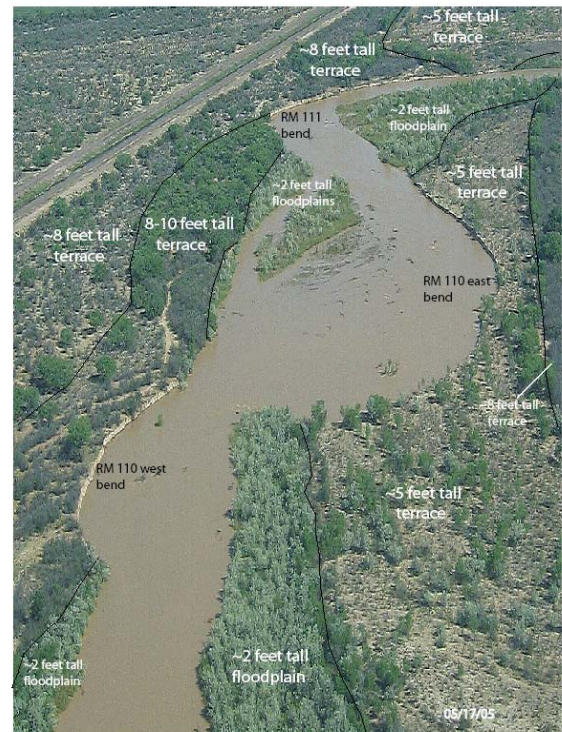
Figure 6: Outline of terraced surfaces and active floodplains between RM 111 and RM 110 on the Rio Grande in the San Acacia Reach; bank heights from the ordinary high water mark (Massong 2005b).

As stated earlier in this report, this bend initially formed in early May 2005, with the first detailed bankline data collected on May 20th, when it was determined that this bankline was rapidly retreating. The bankline location was mapped several times during runoff, and then two times after runoff ended. The initiation of this erosion is concurrent with the downstream migration of the RM110 East bend. The bank material present at this site is historical Rio Grande floodplain and riverine sediments composed of sand and silt. The bank is 8-10 feet higher than the current ordinary high flow (Figure 6) and forms a vertical bank.

Unlike the bank material found at both the RM 111 bend and RM 110 West bend, this bank material was recently (within 20 years) deposited and abandoned riverine sediments. This loosely packed river sand (a.k.a., sugar sand, Figure 12) composes a 5 foot terrace (Figure 6). The vegetation on this terrace is sparse saltcedar, cottonwood, and the occasional Russian olive tree. Shrubs and cacti are also growing on the surface. The bank material appears to offer no resistance to the river erosion.
